## Safety at Half-Signal Intersections in Portland, Oregon

Safety at Half-Signal Intersections in Portland, Oregon

A thesis submitted in partial fulfillment of the  
requirements for the degree of

Master of Science  
in  
Civil and Environmental Engineering

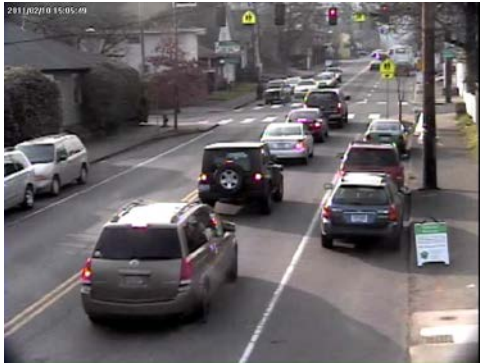
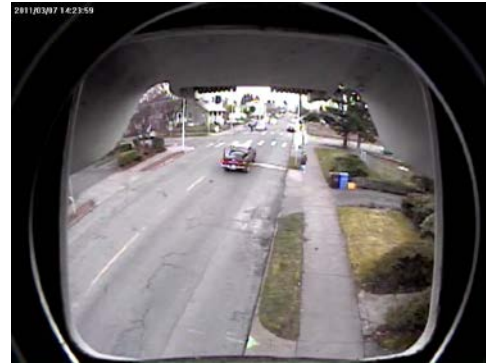
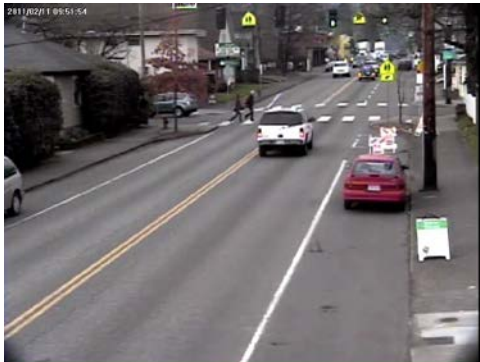
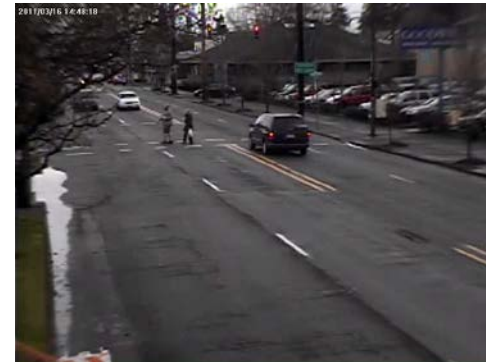
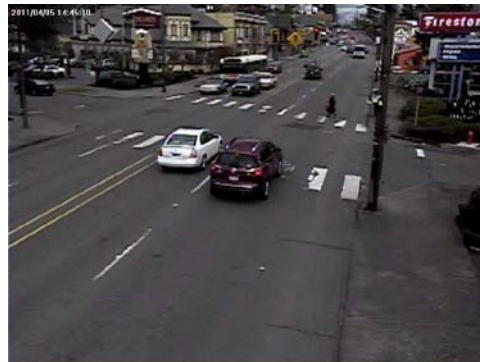
**Figure 13: Sample Screen Captures from Half-Signals**

Video cameras were pole mounted close to each of the five half-signal intersections along the major street. It was requested that the signal head, pedestrian

movements, and vehicles from major and minor roads be visible. A screen capture from each half-signal intersection is shown in Figure 13.
